Integration of SBAS-InSAR Time-series Data into Maintenance Prioritization of Linear Rail Infrastructure In Bangladesh

Khin Myat Kyaw^{1*}, Wataru Takeuchi¹

¹ Institute of Industrial Science, The University of Tokyo, Japan

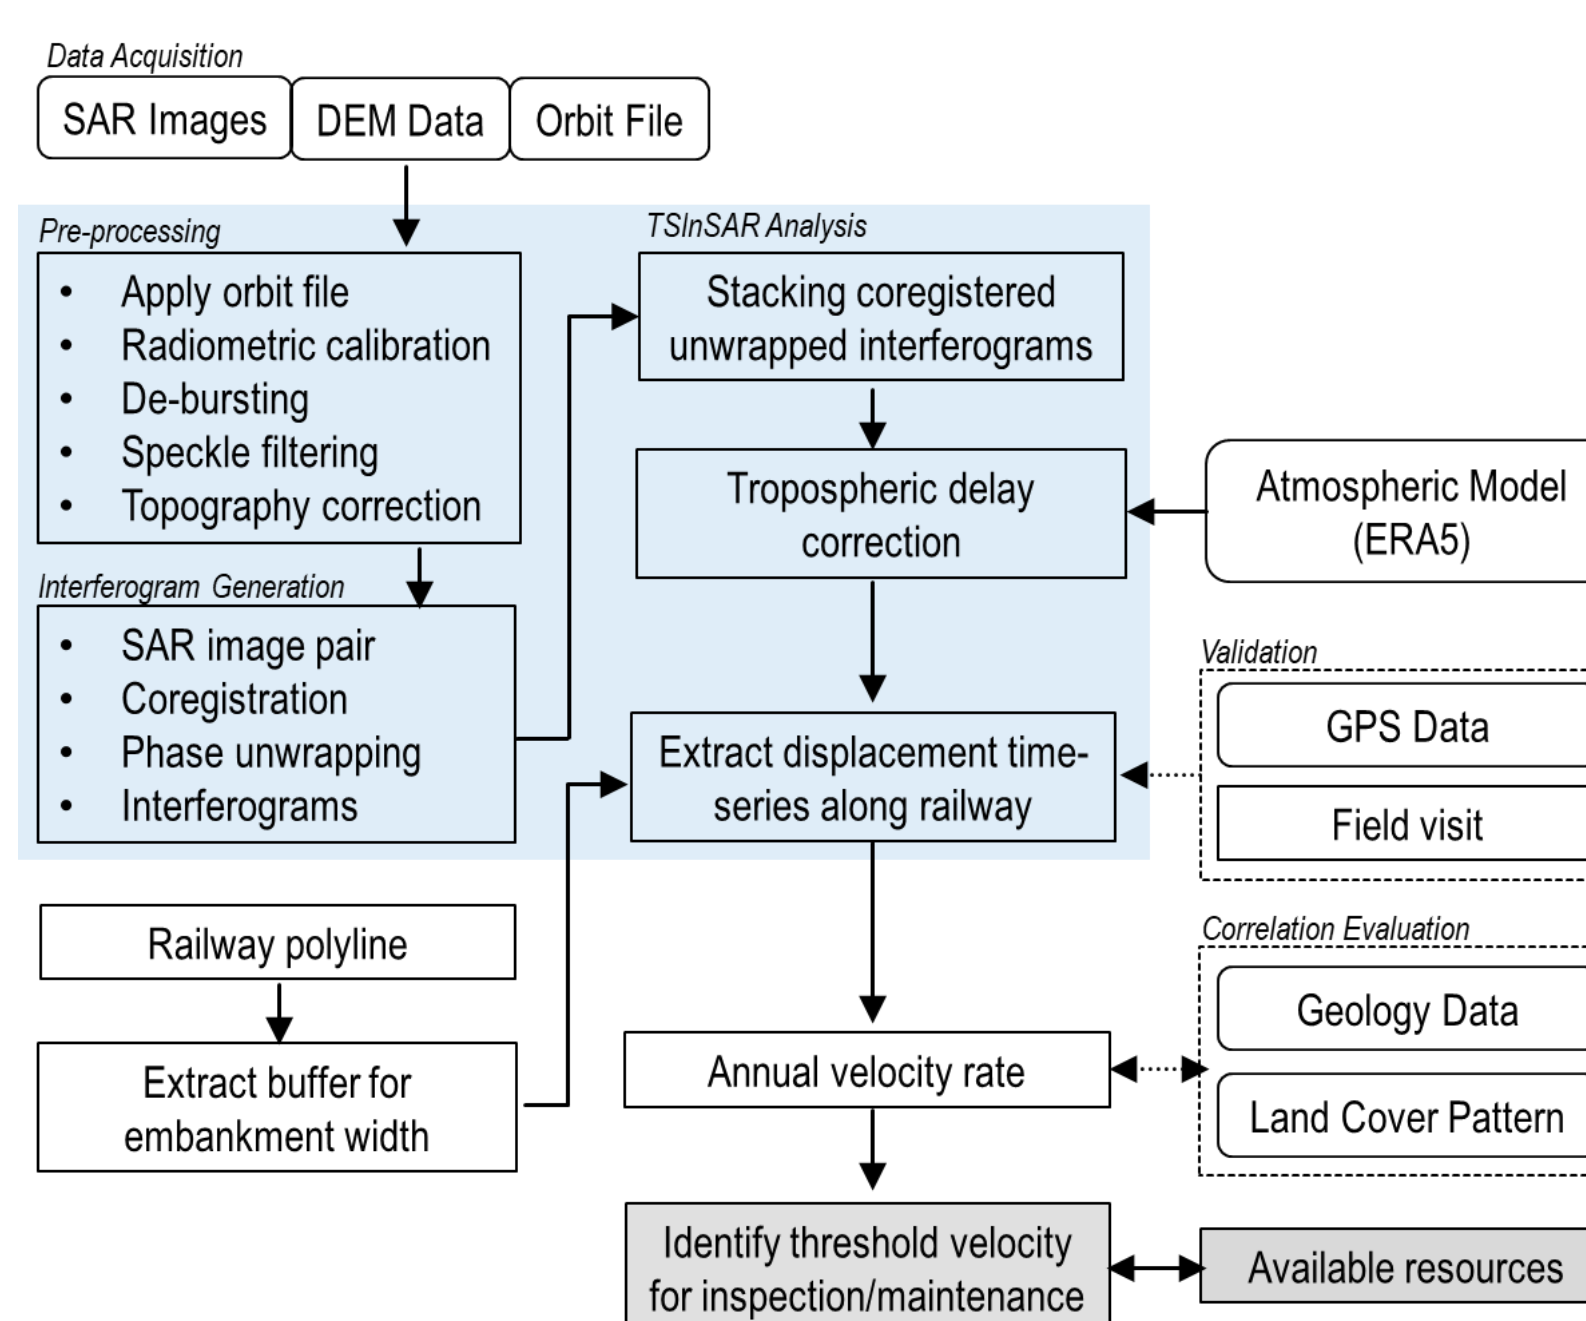
Fig1. Research Framework.

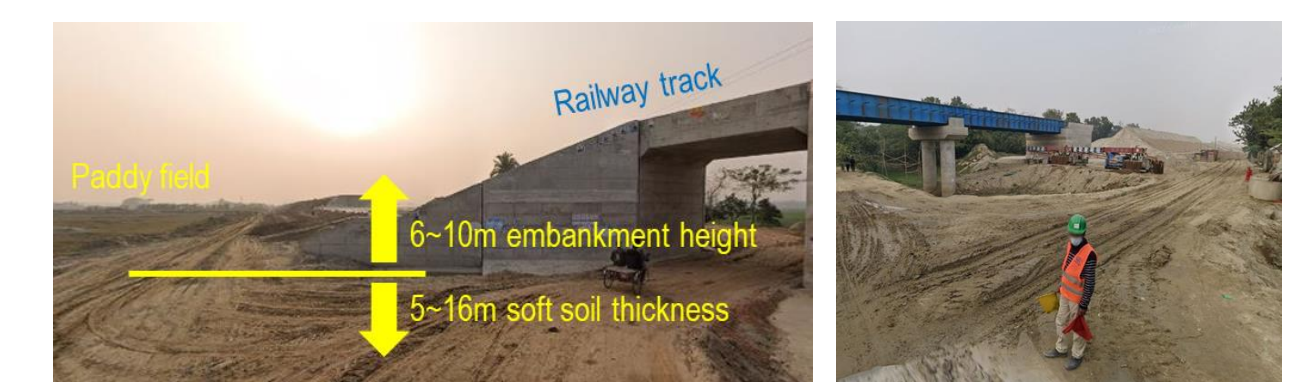
Fig2. Embankment constructions (google street view).

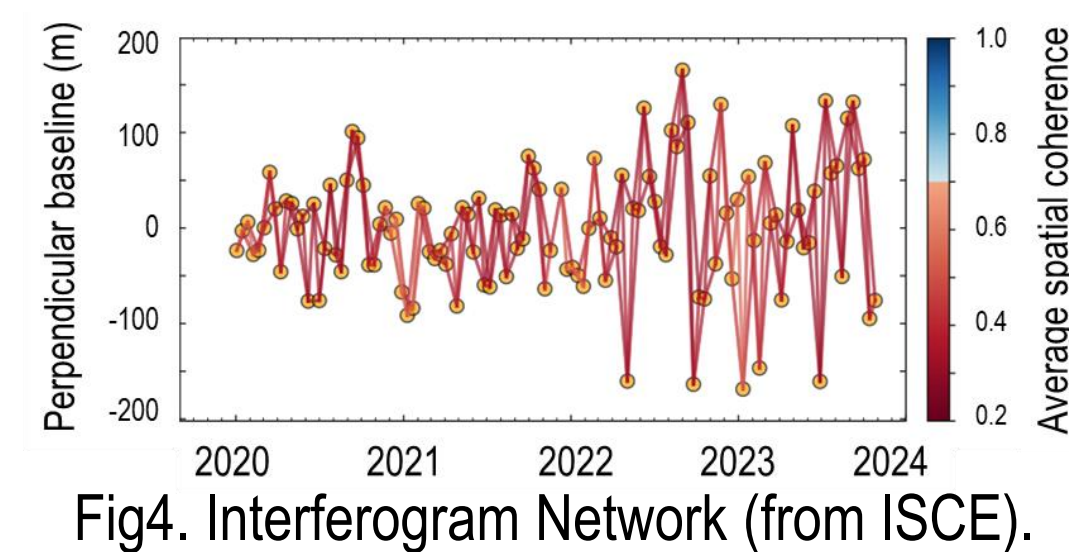
Fig4. Interferogram Network (from ISCE).

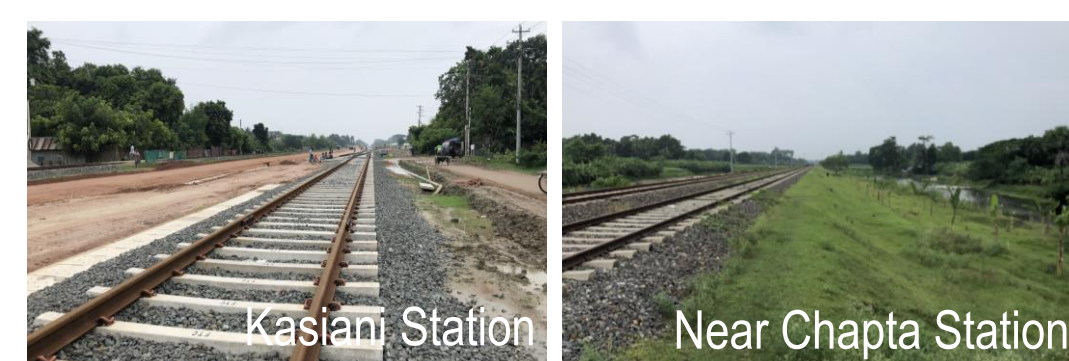
Fig5. Field visit to Kasiani and Chapta Station.

- SBAS-InSAR result shows an agreement with LOS-projected GPS data (Fig-7) and field visit (Fig-5 & Fig-8). Location A (Kasiani Station Fig-5 left, built area, no elevated embankment) → LOS velocity ~ +10 mm/yr (Fig-8) Location B&C (near Chapta Station Fig-5 right, crop land, ~10m elevated embankment) → LOS velocity >20 mm/yr.
- InSAR exhibits LOS displacement rate ranging from -60 to +20 mm/yr along railway line (Fig-6 & Fig-8).
- InSAR result indicates that railway line passing paddy field area has a high potential of instability (Fig-9 left). "Crops" land cover type ~ -20 mm/yr.
- High rate of LOS displacement rate reported on "Alluvial silt and clay" soil type, followed by "Deltaic silt" and "Marsh clay and peat" type (Fig-7 right).

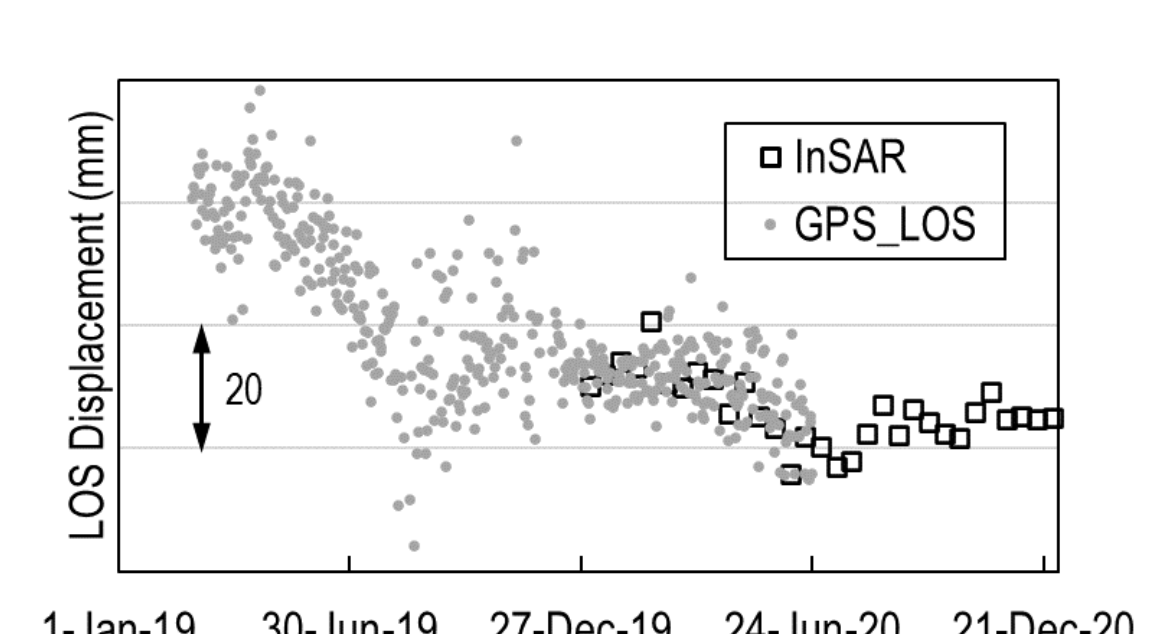
$$v_{los} = \begin{pmatrix} -\sin\theta\cos\alpha \\ \sin\theta\sin\alpha \\ \cos\theta \end{pmatrix} \begin{pmatrix} v_E \\ v_N \\ v_V \end{pmatrix}$$

Fig7. Validation with GPS data.

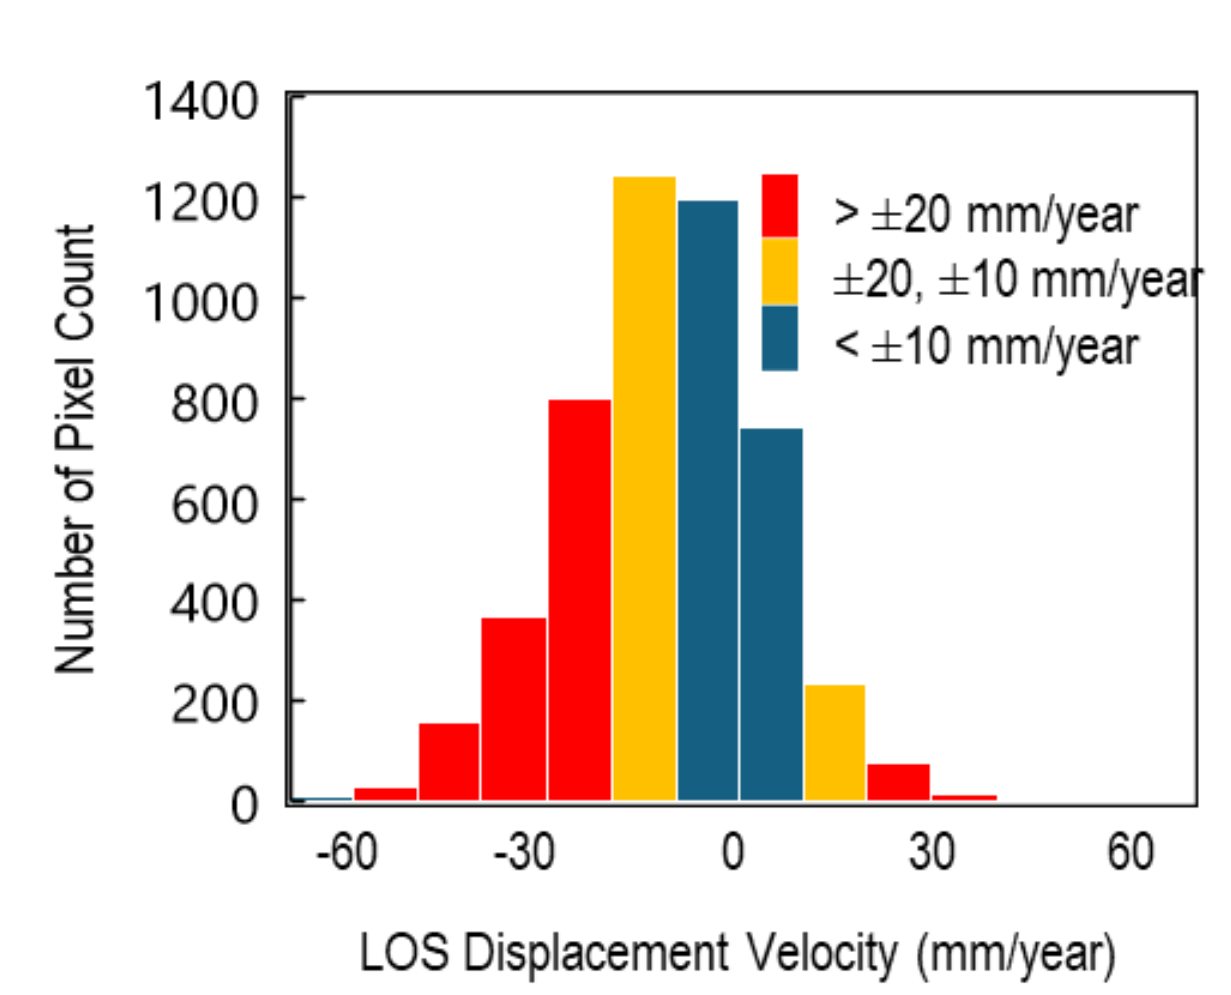
Fig10. Pixel count for different LOS displacement.

- Application of InSAR results in SHM Threshold velocity Fig-10 (prioritization → resources) > ±20 mm/yr, (red) (~ 30% of total pixel count) between ±10 and ±20mm/yr (orange) < ±10 mm/yr (blue)
- Multi-looked ~ 30x30m resolution for InSAR result.
- Future work → detailed analysis on current damage condition in correlation with InSAR result.
